Safety Engineering and Standards Luminaires falling to ground

Incident Description

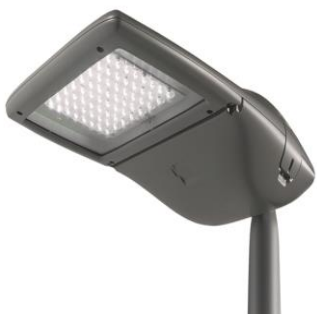
The Urbis-Schreder Ampera failures manifested themselves when the bolts holding the luminaire to the spigot adapter sheared. There was some evidence to show that the unit hung by its electrical cabling before falling. Subsequent ground level inspections indicate the units droop by 15 degrees prior to falling.

The underlying cause of the bolts failing and loosened bolts is under investigation as a matter of priority by SES technical experts as well as the manufacturers'.

All sections of the network where Urbis-Schreder Ampera and Philips Luma 2 and 3 are fitted are to be subject to a higher level of inspection than normal to identify fallen, hanging or drooping luminaires.

Any compromised luminaires are to be removed within 24 hours. Any fallen luminaire incidents need to be recorded on Airsweb as per IAN 128.

Where compromised luminaires cannot be removed within the stated time period, then any lane below or close to the luminaire is to be closed off until the luminaire can be retrieved.
